# SOIL DIAGNOSTIC ASSESSMENT

City of El Paso Parks and Recreation  
New Park Development Site – Modesto Gomez Park  
4600 Edna Ave, El Paso, TX 79905  
Sites MG001 - MG004 | Approximately 1.5 Acres

Prepared by:  
**AURUM TECH, LLC**  
El Paso, Texas

January 2026

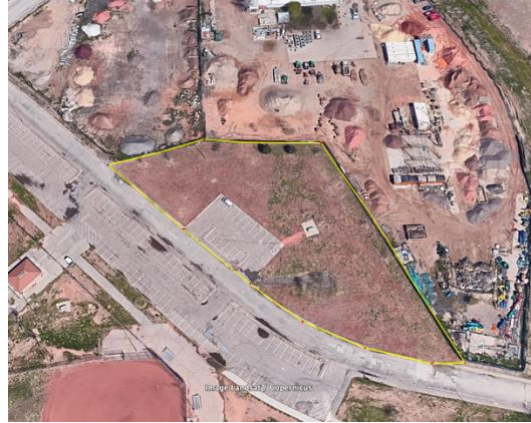
**FINDING:** All four sampling sites exhibit severely compromised soil health requiring remediation before successful ornamental establishment can be expected.
